BRADFORD CITY No. 2 DAM

NDI No PA 00024
PennDER No. 42-8

PHASE I INSPECTION REPORT
NATIONAL DAM INSPECTION PROGRAM

February 1979

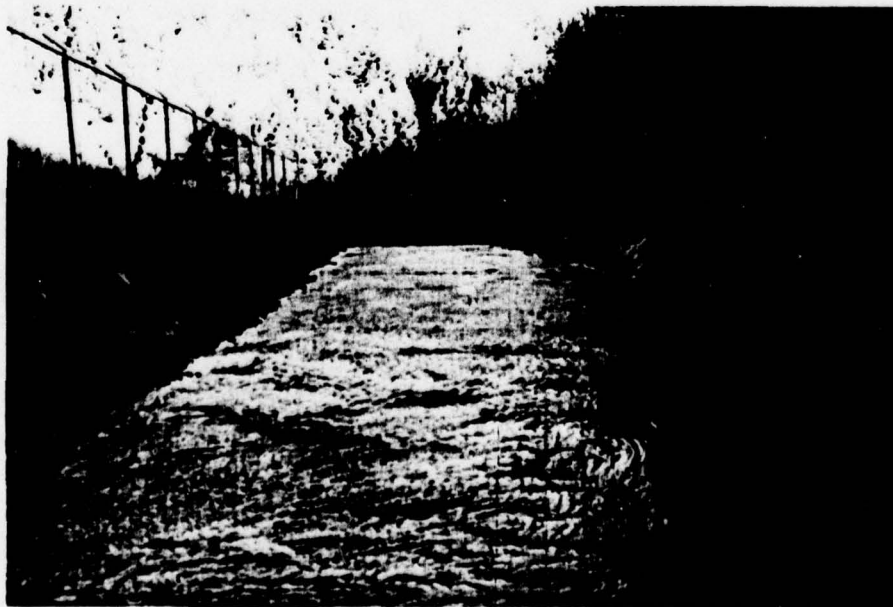
- c. Appurtenant Structures - The concrete overflow spillway located at the right abutment of the dam has signs of cracking and minor spalling. Also, the spillway channel exiting into the rapid chute has signs of deterioration. This deterioration is not abnormal for the age of the concrete and the water authority has used asphalt sealer to patch the cracks. However, continued maintenance and repair of the concrete areas will be necessary in the future to prevent rapid deterioration and total replacement of the areas.

PHOTO 4. View of Spillway Chute

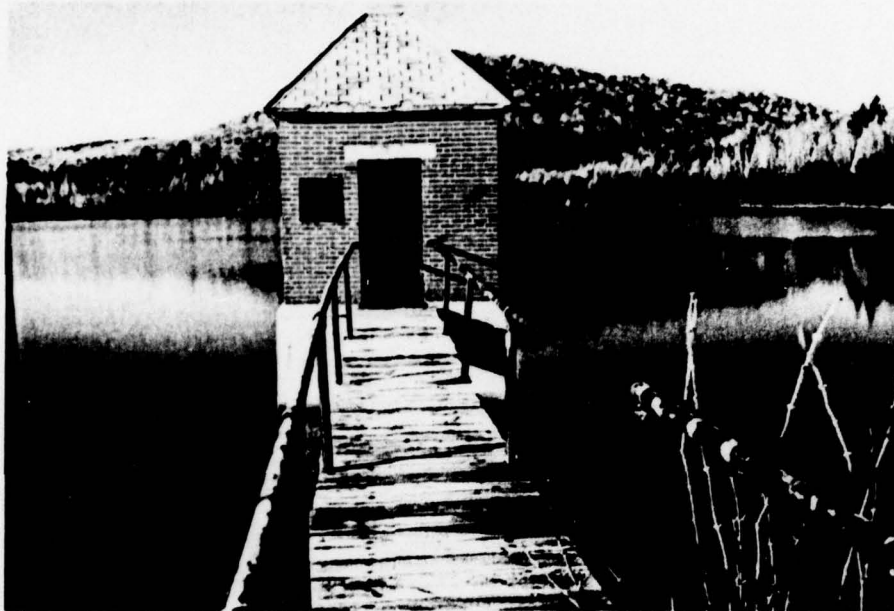
PHOTO 9. View of Intake Tower and Walkway
